NASA Contractor Report 181945

**DEVELOPMENT AND FABRICATION OF STRUCTURAL
COMPONENTS FOR A SCRAMJET ENGINE**

**Contract NAS1-16097
March 1990**

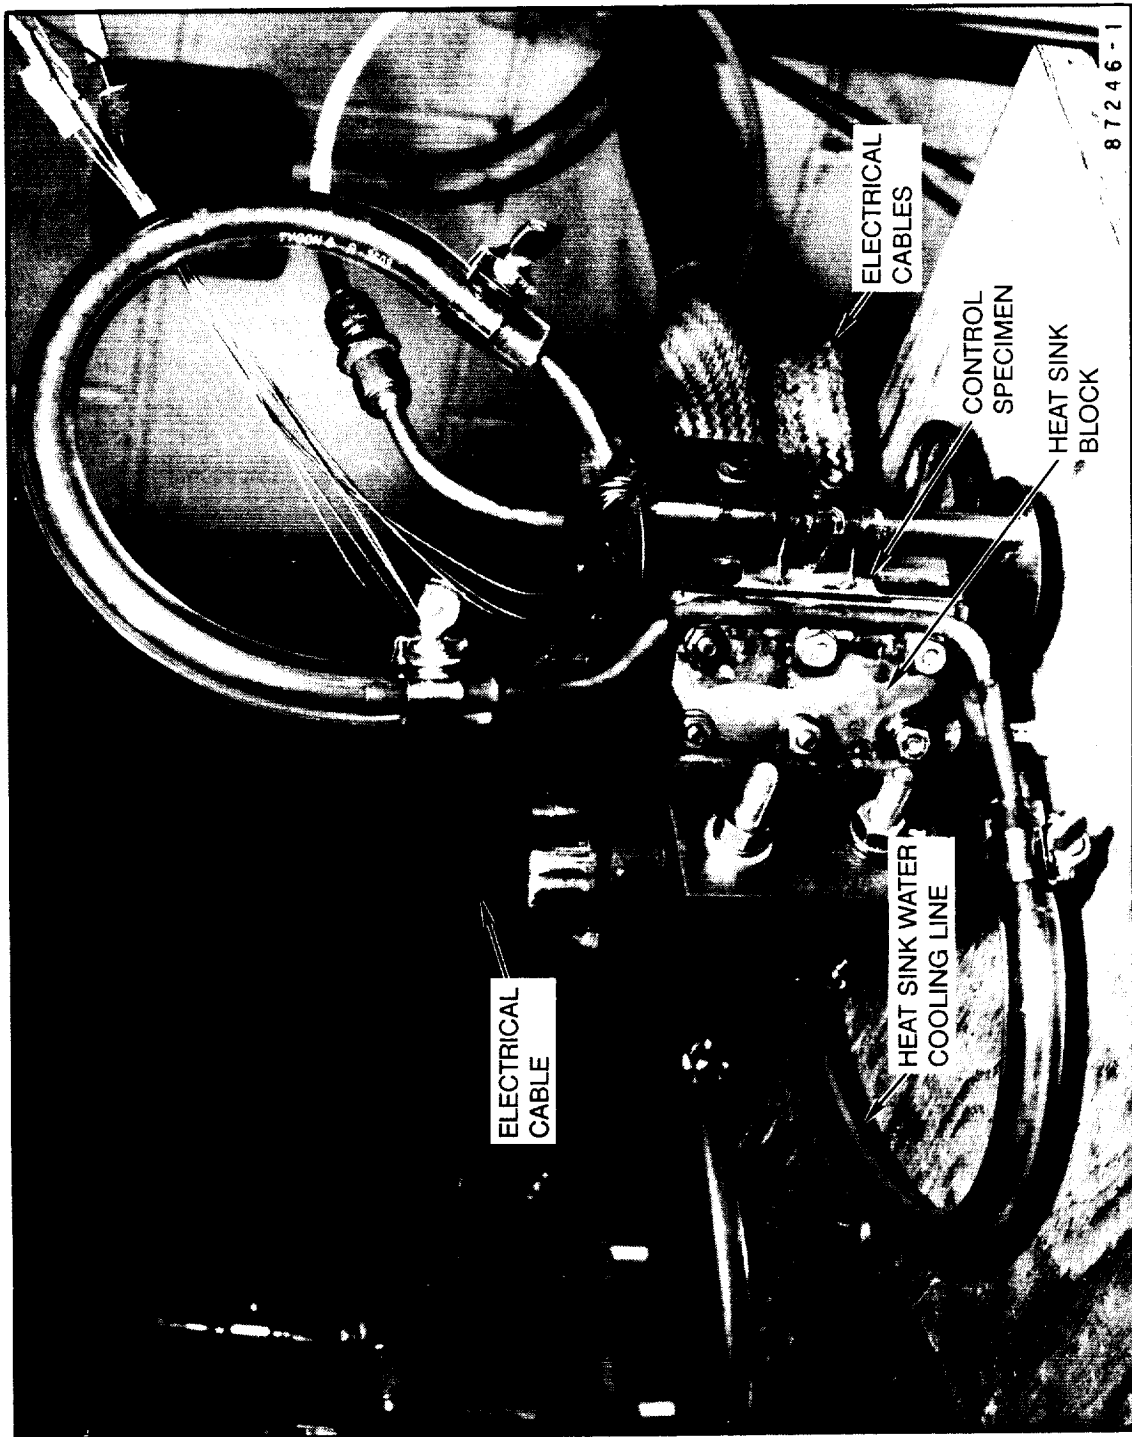
Figure 68. Control Specimen Instrumentation, Electrical Resistance Heating Test Setup

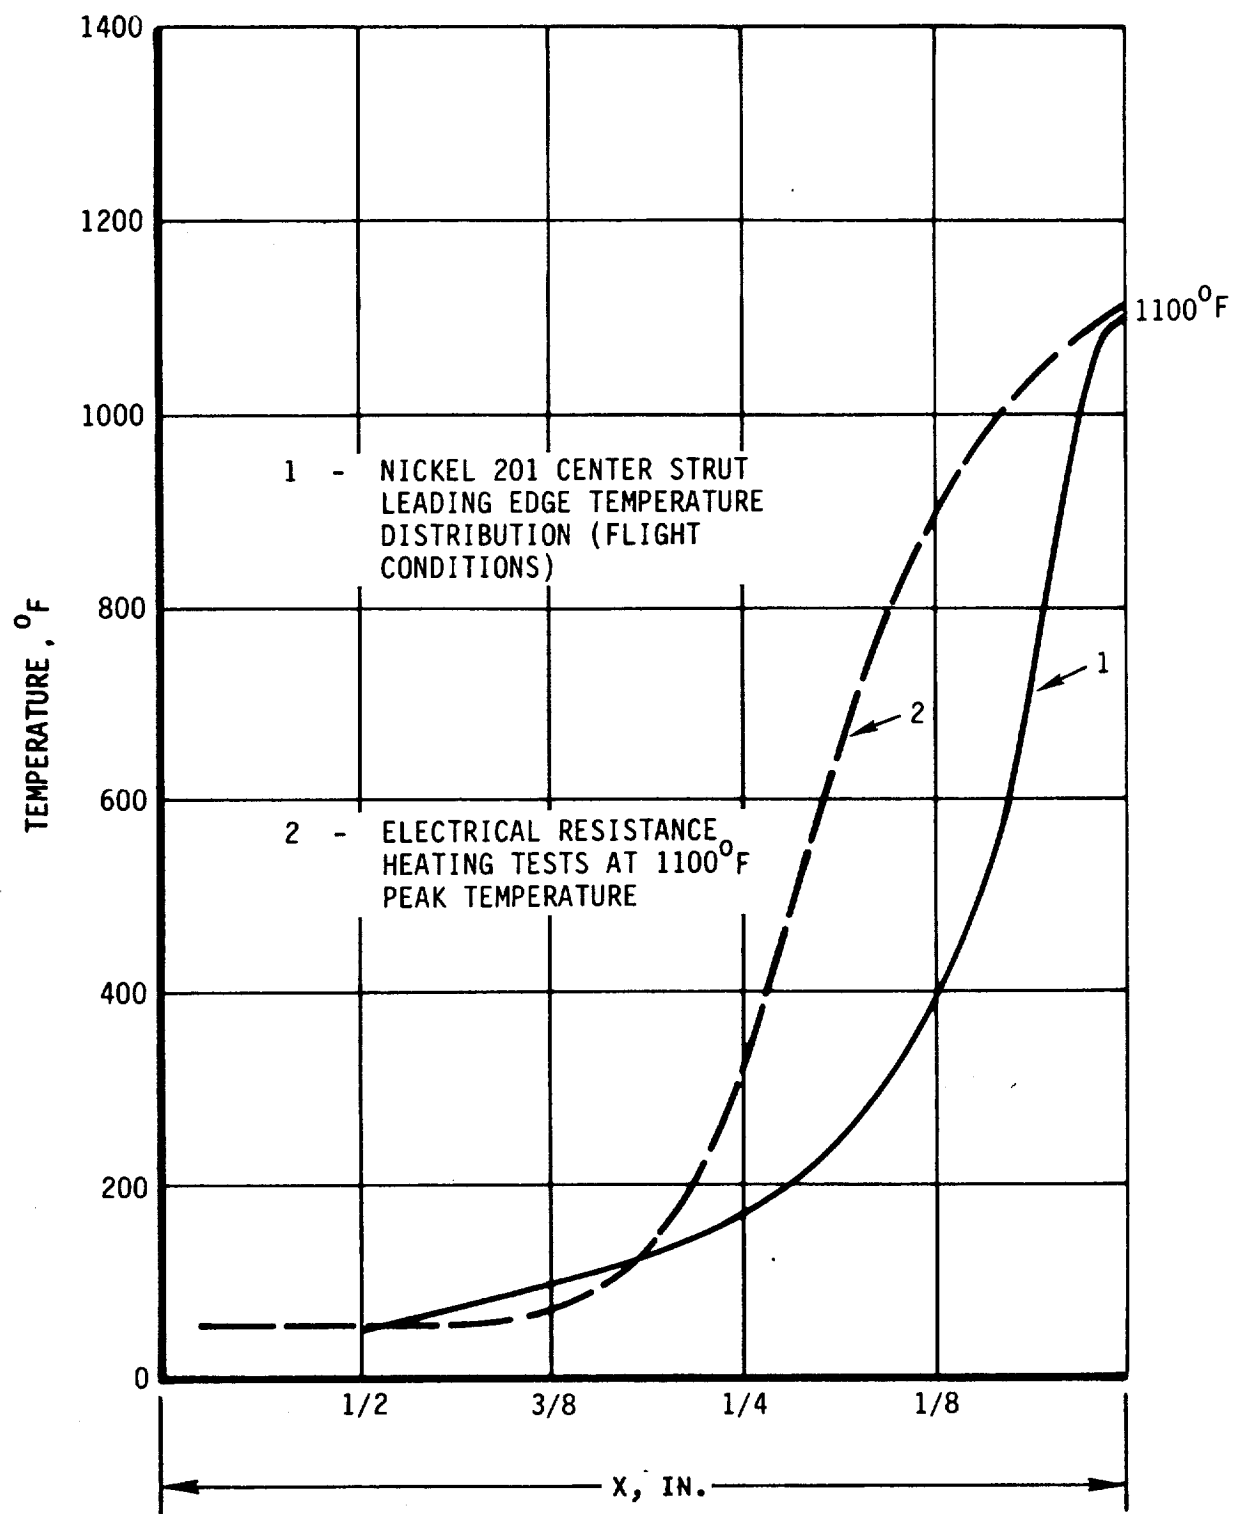
Figure 70. LCF Test Specimen Temperature Distribution Using Electrical Resistance Heating

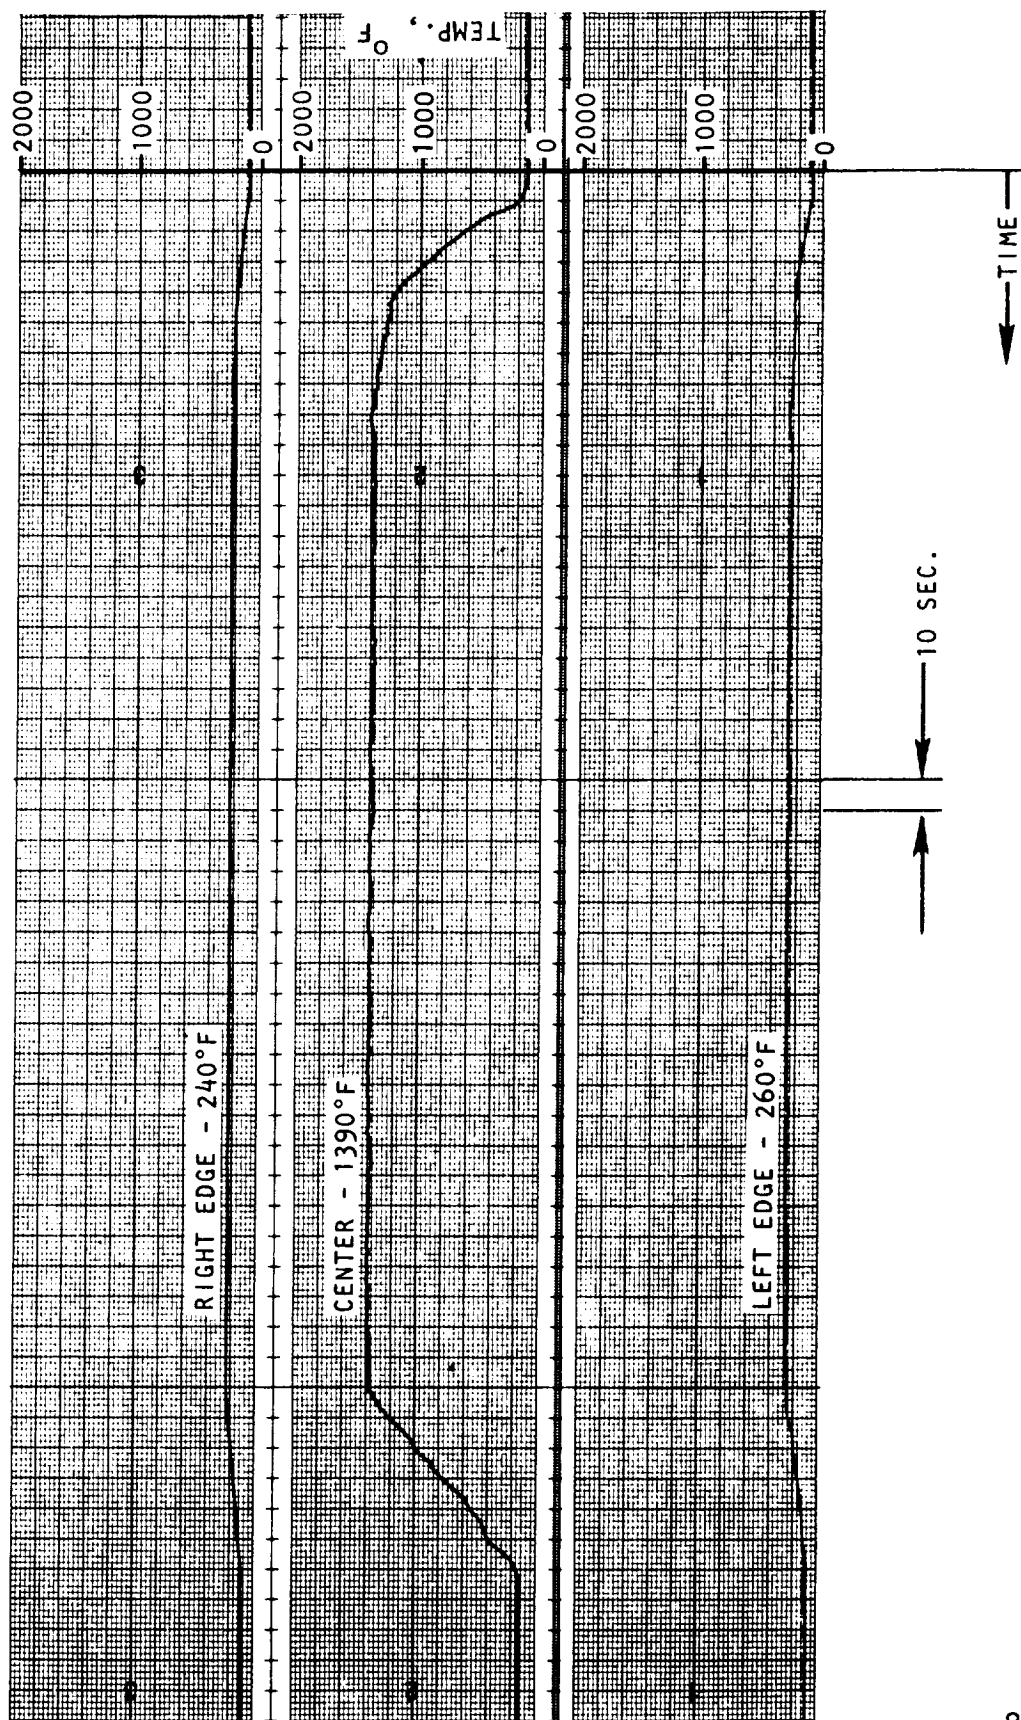
Figure 71. A Combined LOF and Creep Calibration Test Cycle Using Electrical Resistance Heating

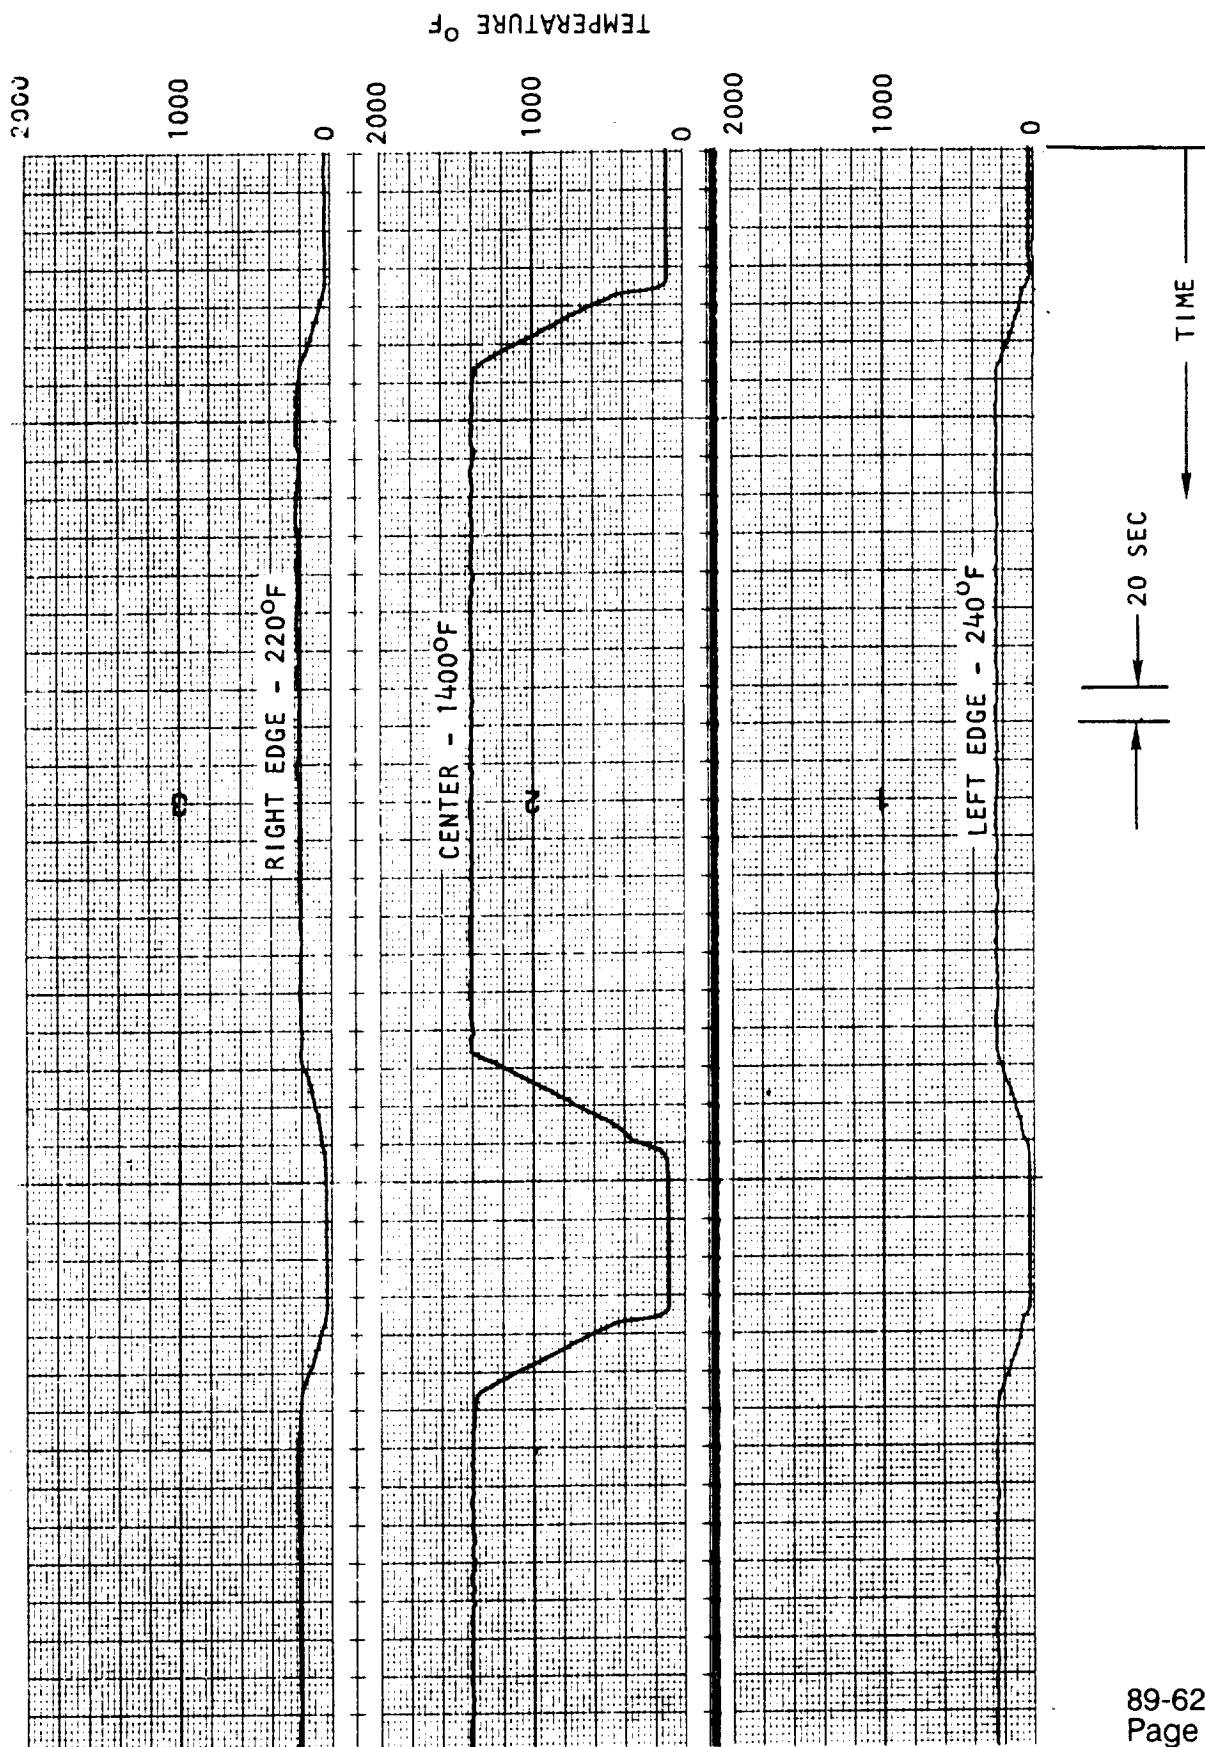
Figure 72. A Typical Combined LCF and Creep Test Cycle Using Electrical Resistance Heating

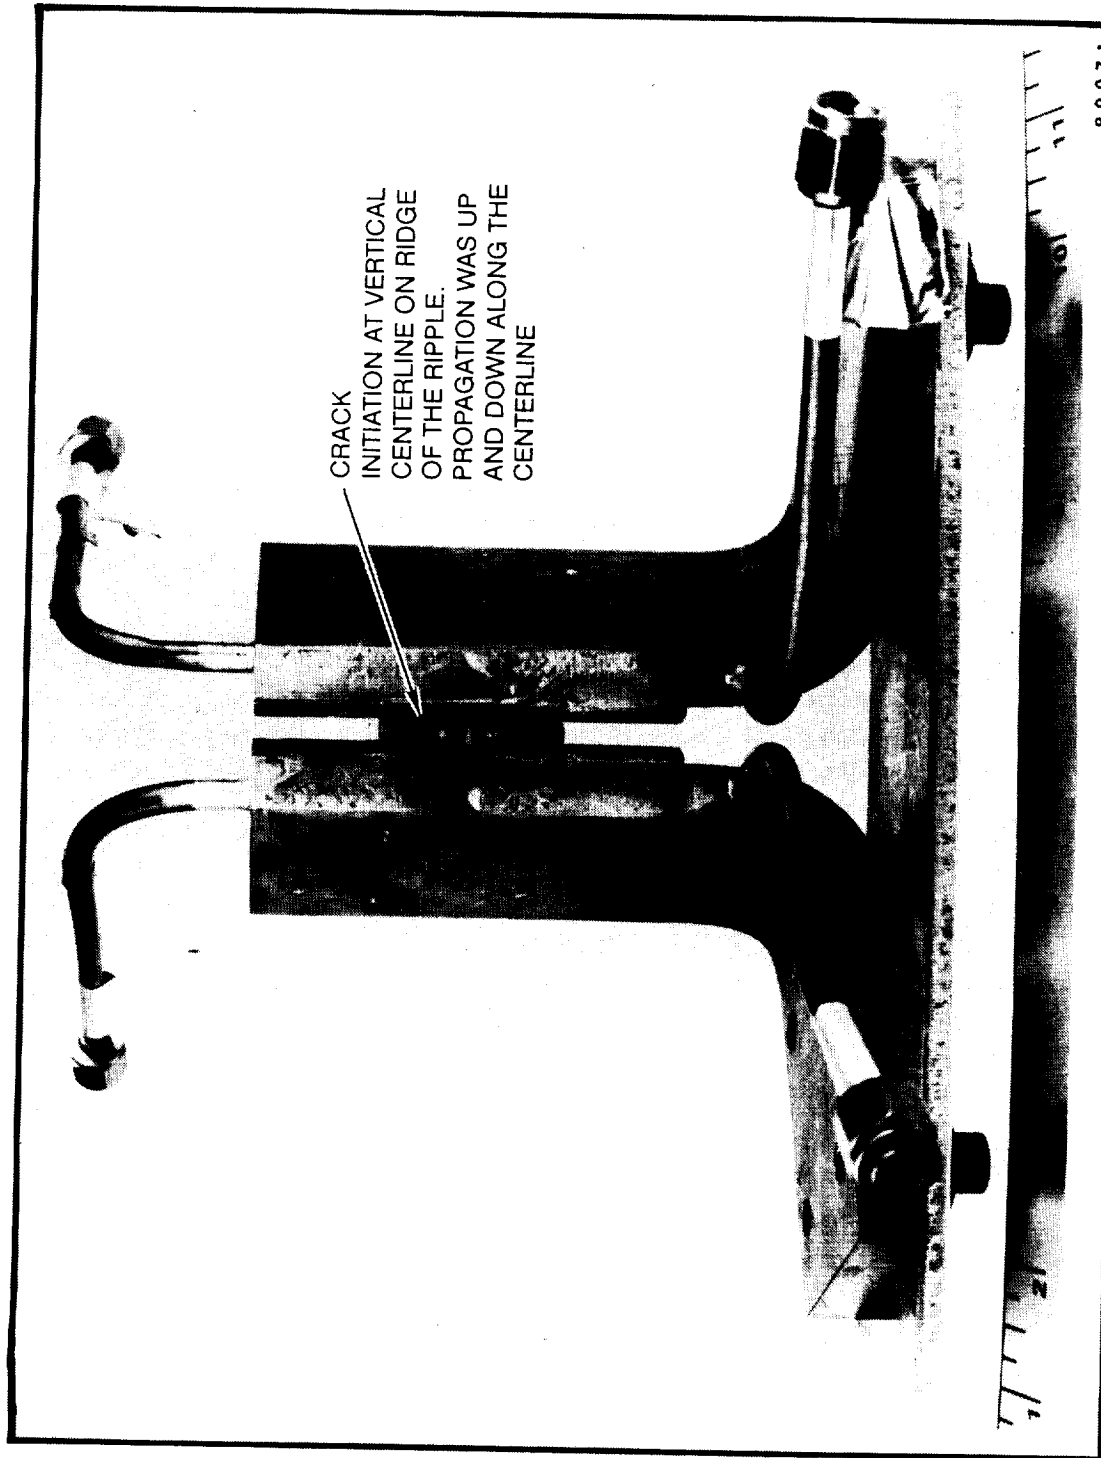
Figure 73. Nickel 201 Electrical Resistance Heating Test Specimen
After 214 Combined LCF and Creep Cycles

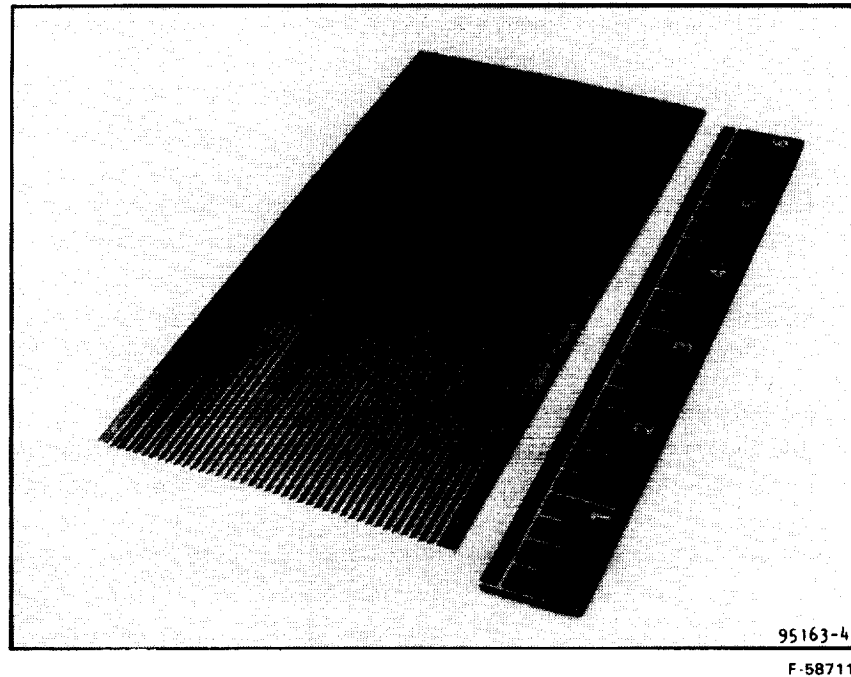
Figure 81. Grooved Flat Specimen (0.005-in.-deep and 0.025-in.-wide groove)

Finally, the susceptibility to a collapse of the cooling jacket at the breaks in the side contours of the strut was evaluated. A previously fabricated pin-fin cooling jacket specimen was used. The solid header bar was cut off on one side of the cooling jacket assembly to simulate the long, unstiffened area encountered in the full-length strut. No difficulties

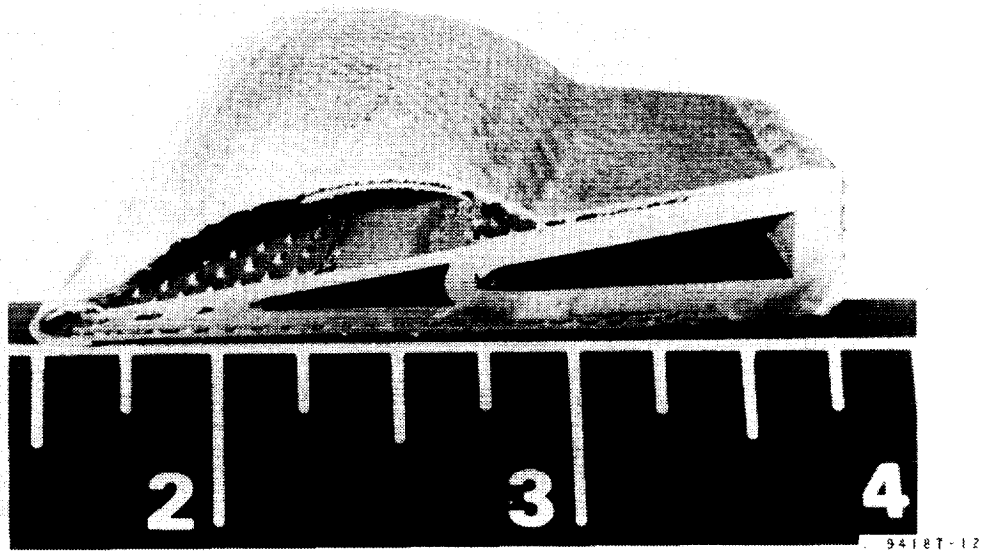
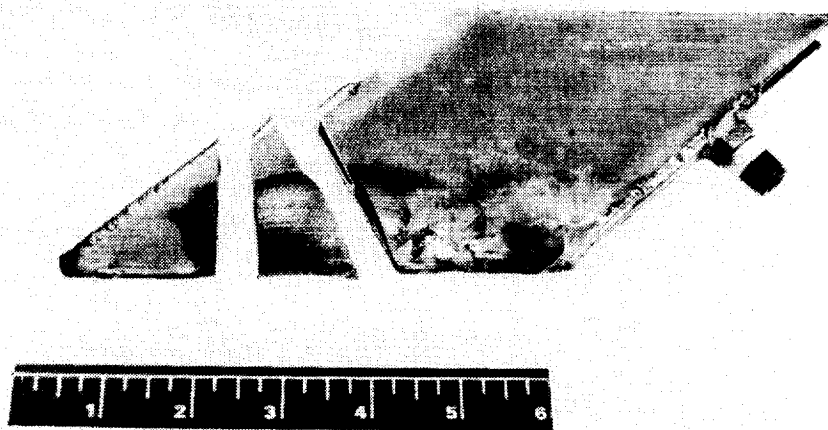
Figure 90. Leading Edge Test Specimen After 2750-psig Rupture

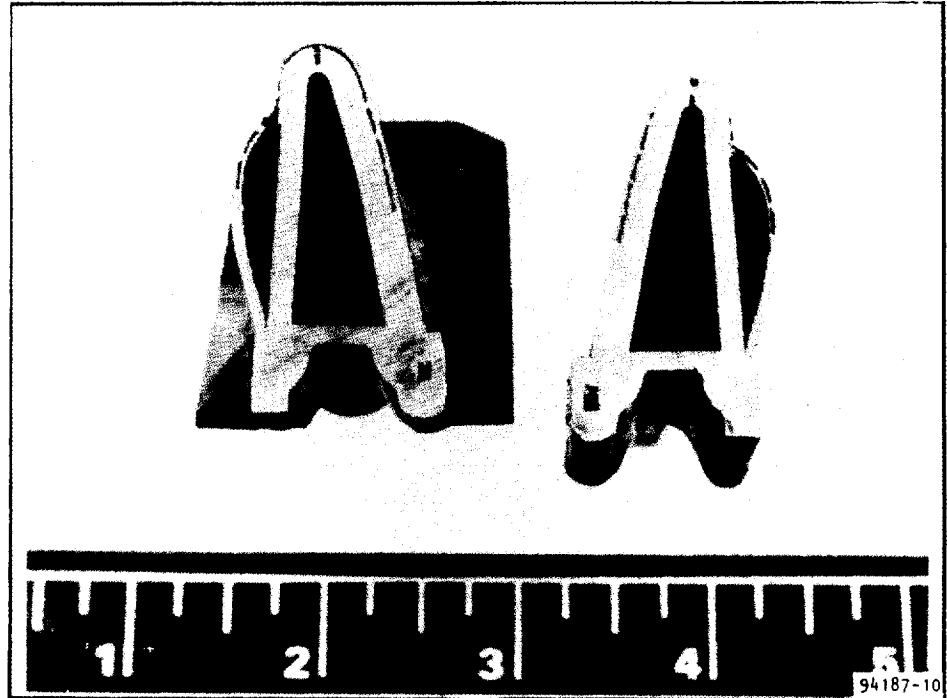
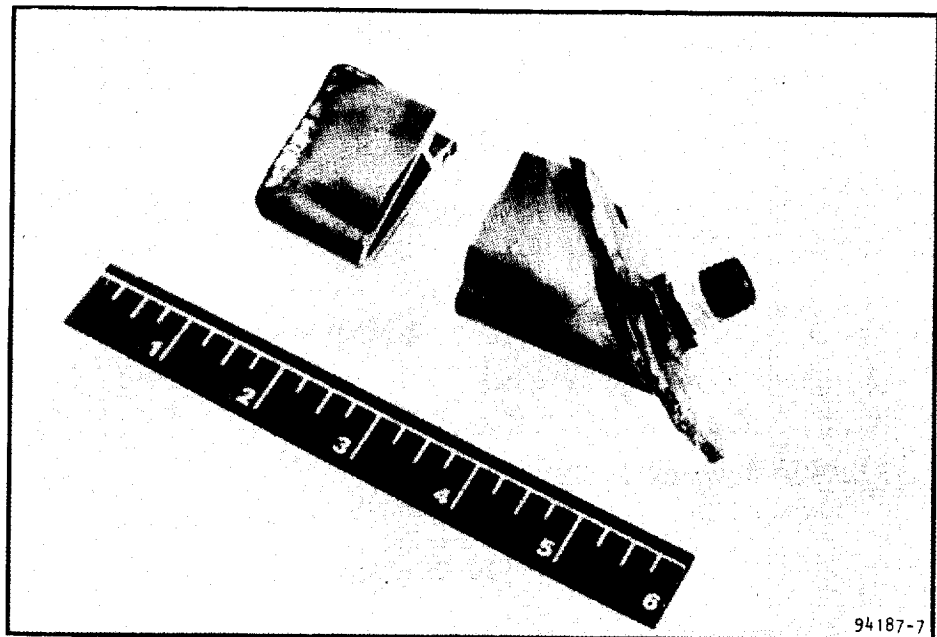
Figure 91. Trailing Edge Test Specimen After 2900-psig Rupture

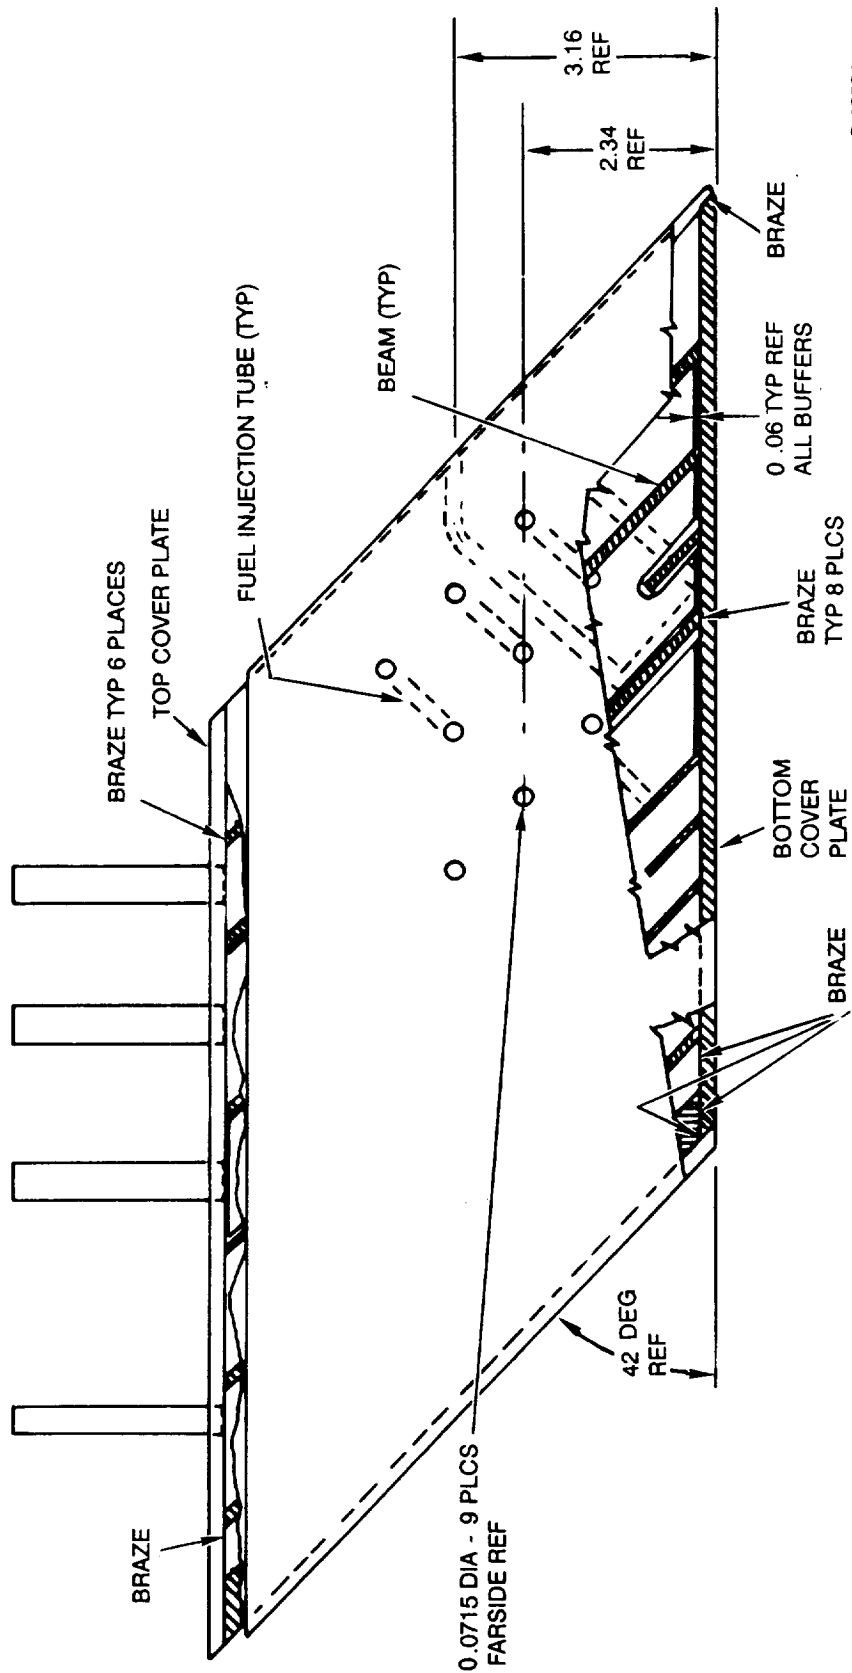
Figure 93. PL Strut Assembly

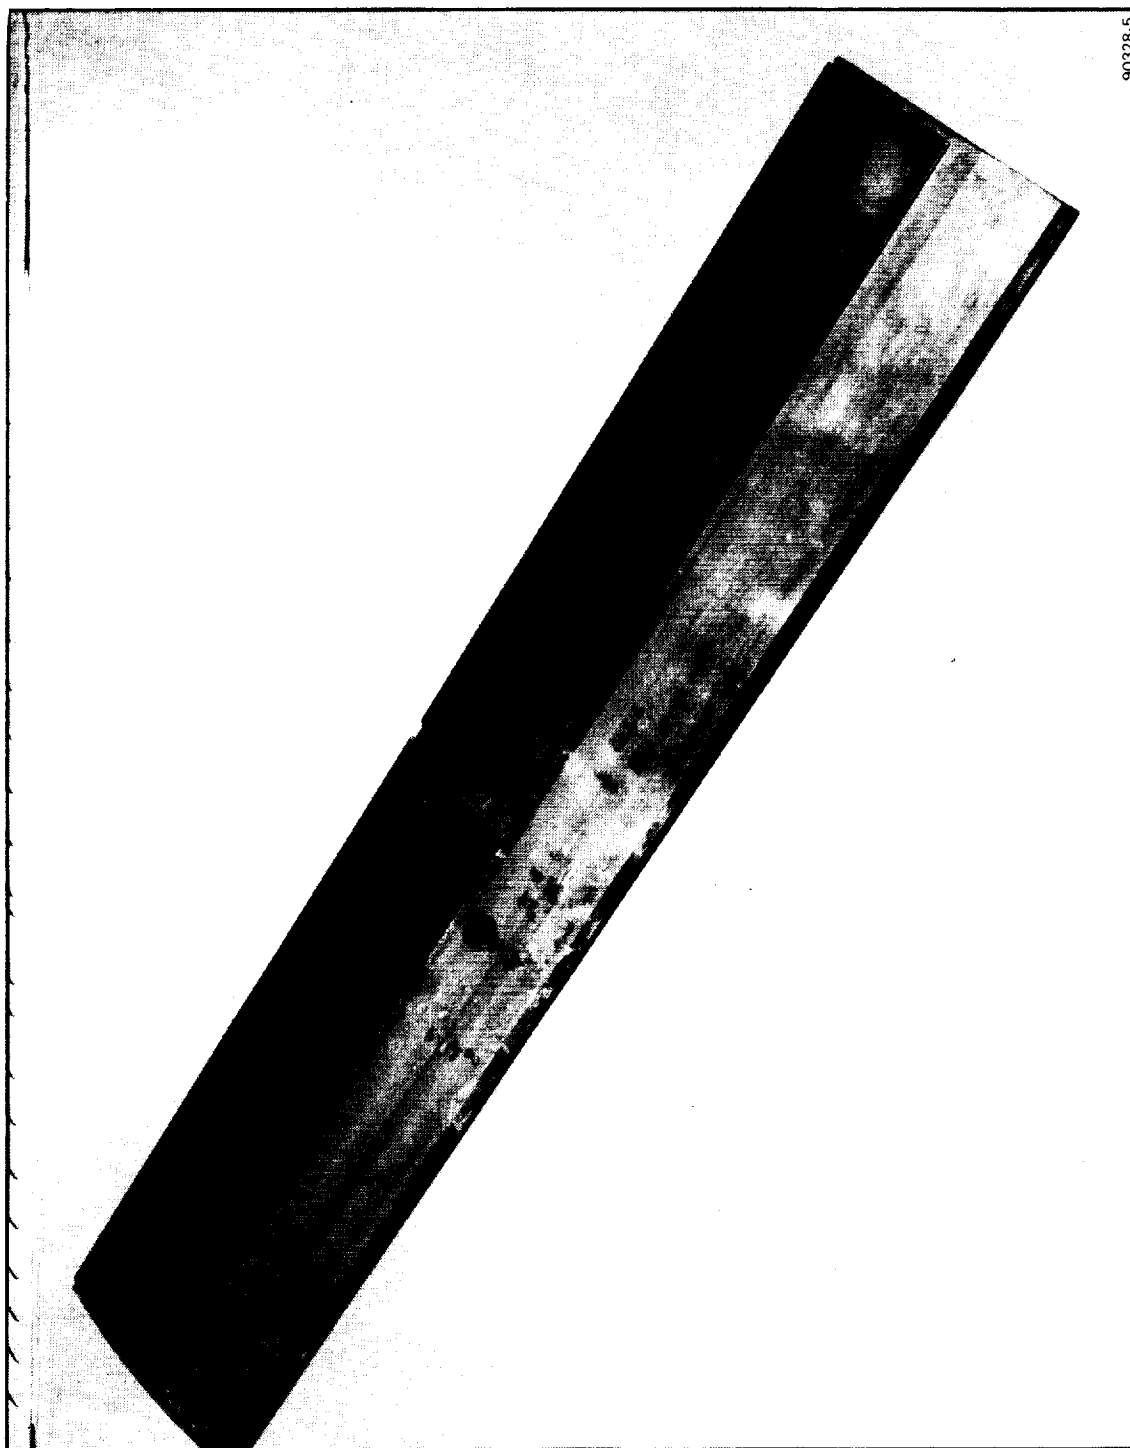
Figure 94. Two Hot-Sized Partial-Length Forward Support Structures on Form Die

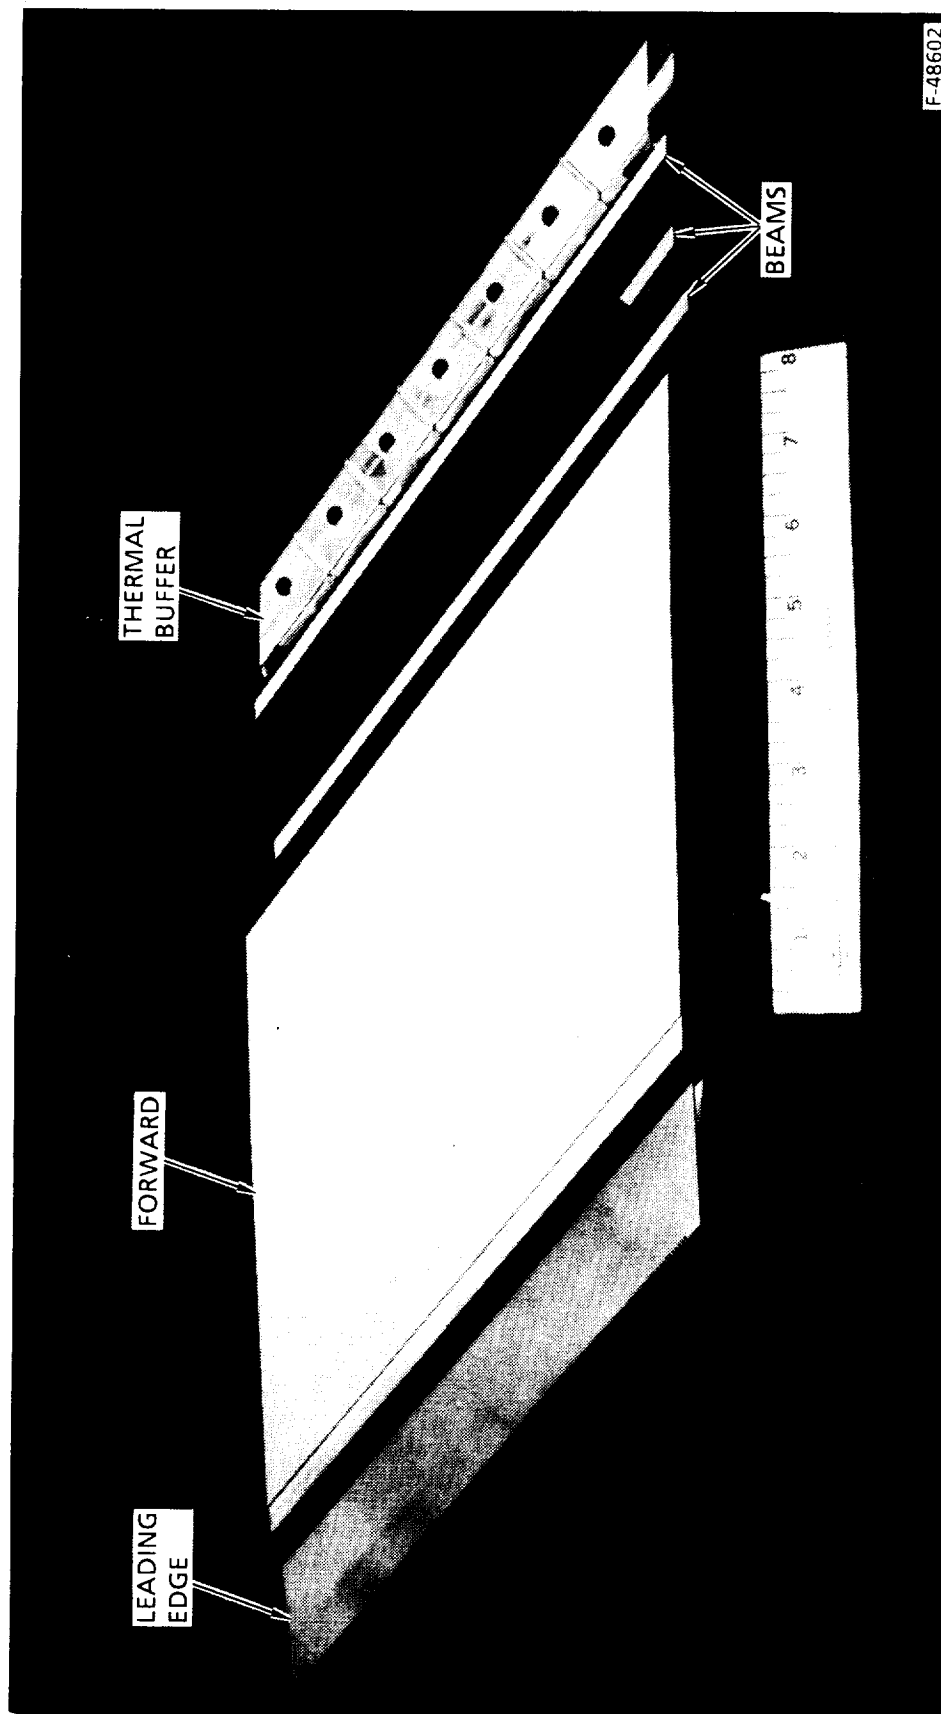
Figure 101. Details of Forward Portion of Partial-Length Strut Support Structure

The major detail parts used in the first partial-length strut (PL1) are shown in Figures 101 and 102, and include the forward and aft support structures, and the leading edge.

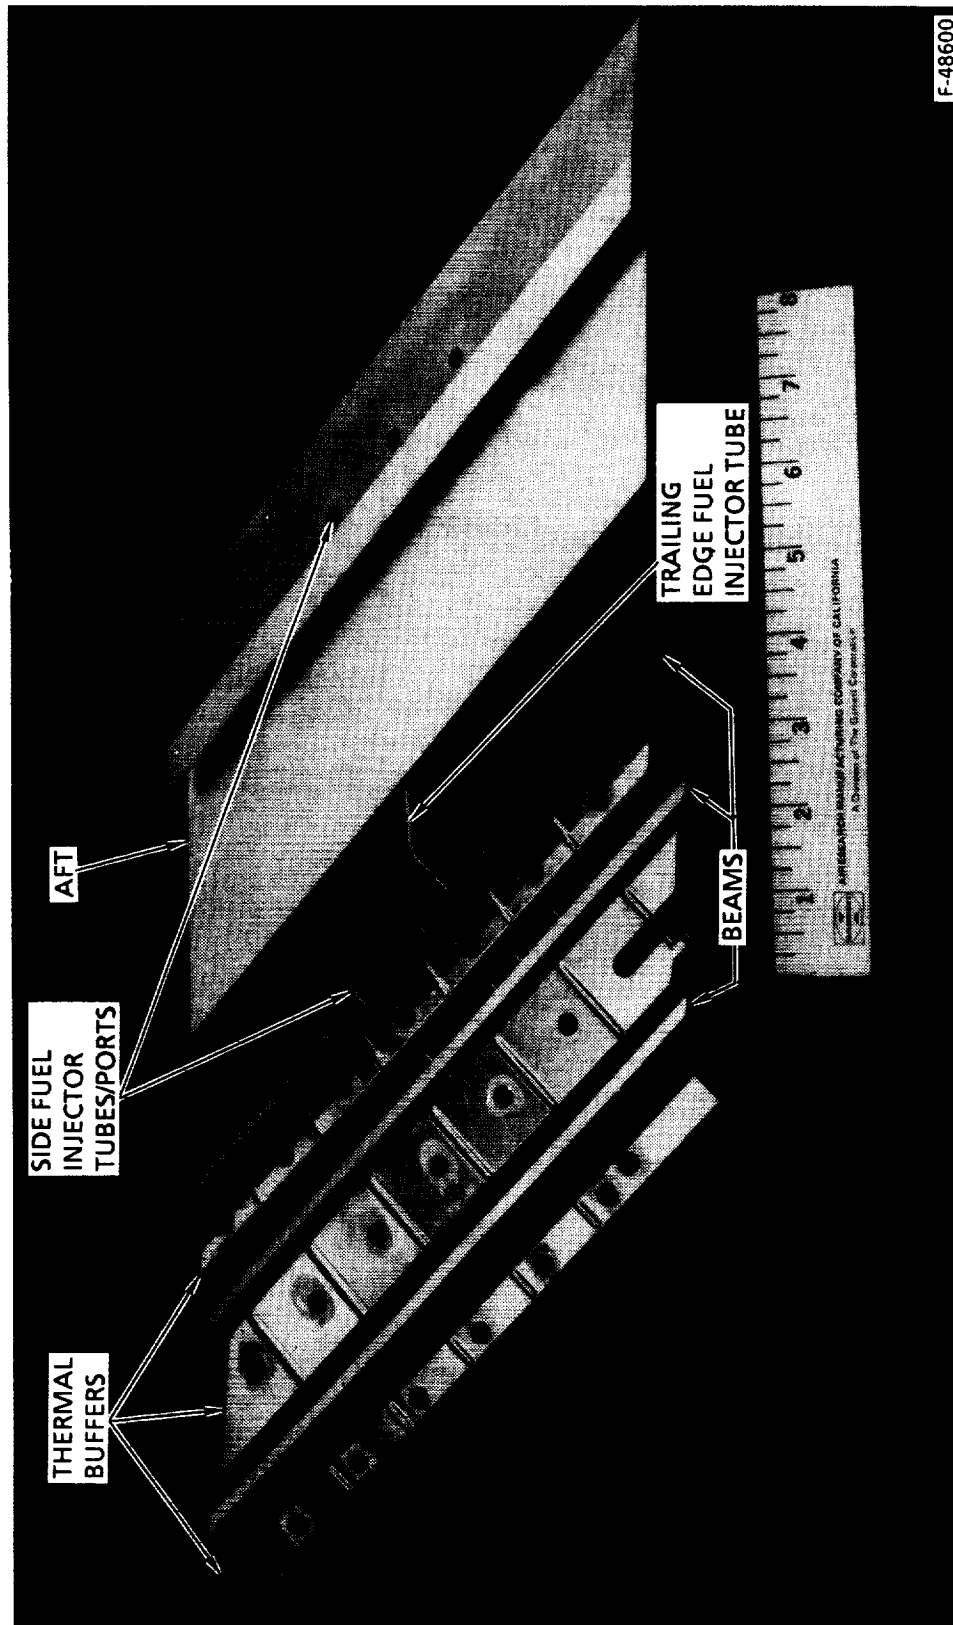
Figure 102. Details of Aft Portion of Partial-Length Strut Support Structure

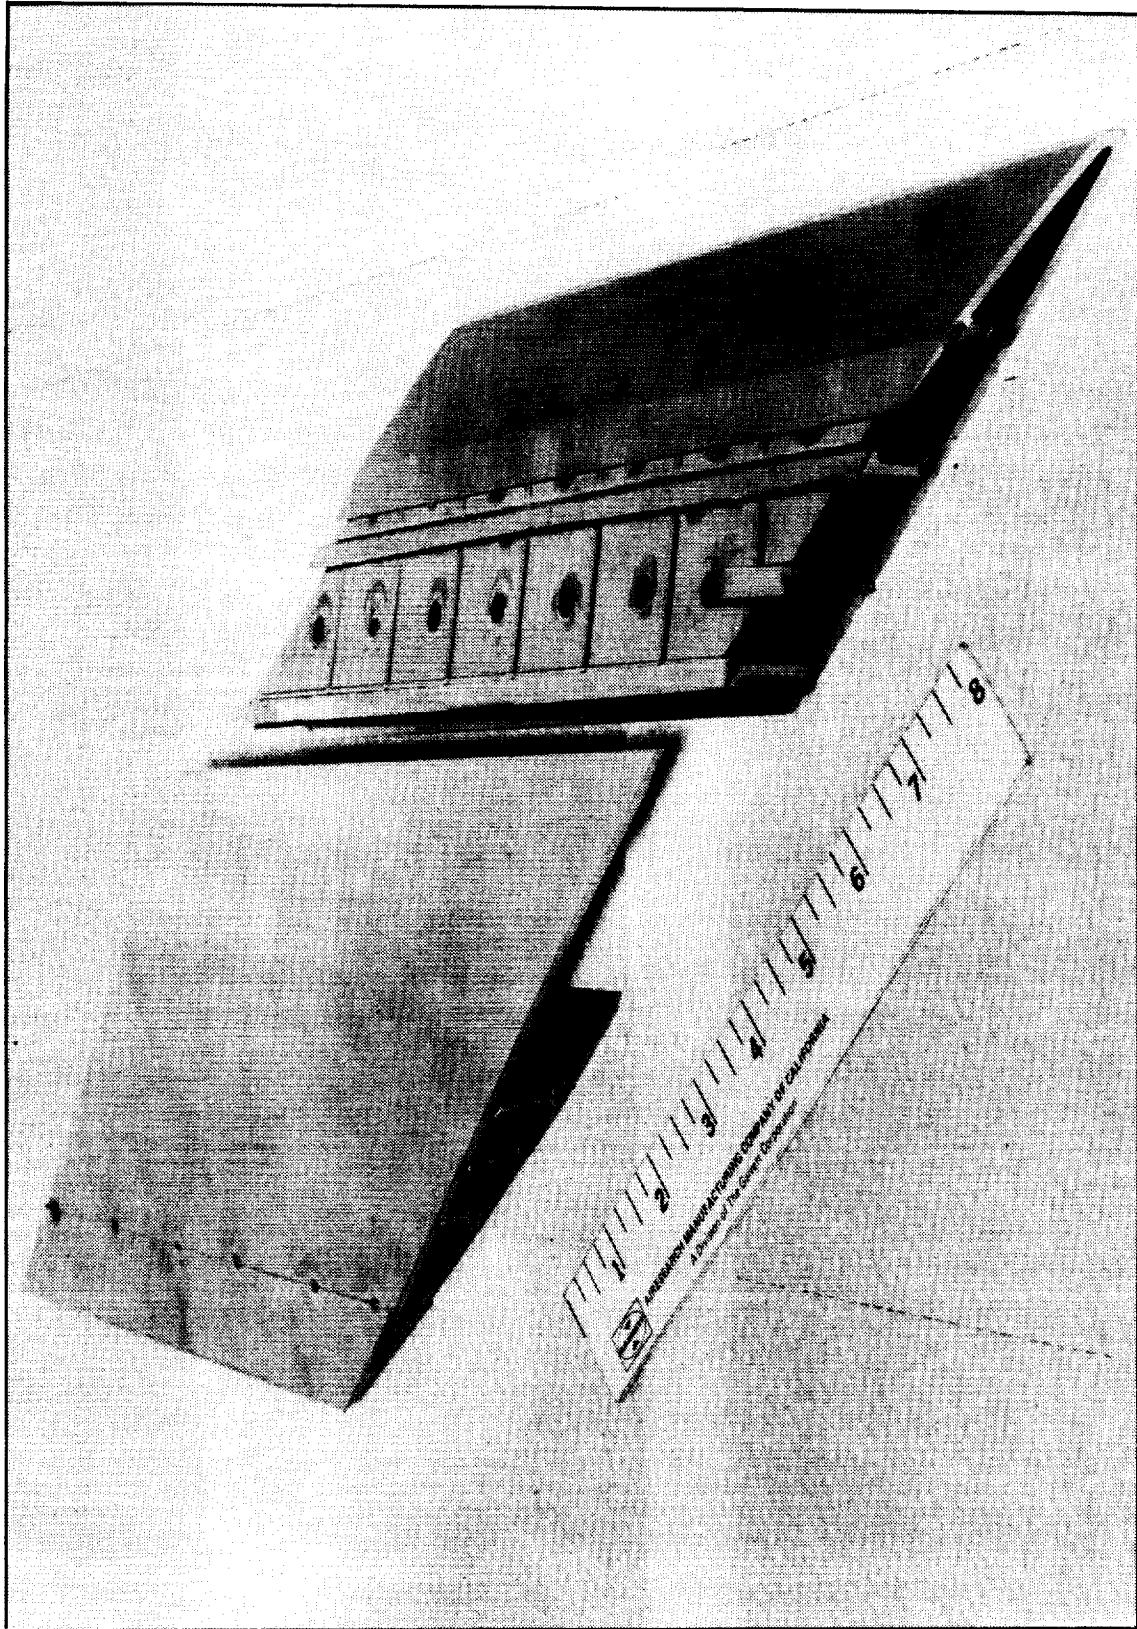
Figure 105. Assembled Forward and Aft Partial-Length Strut Details Prior to Braze

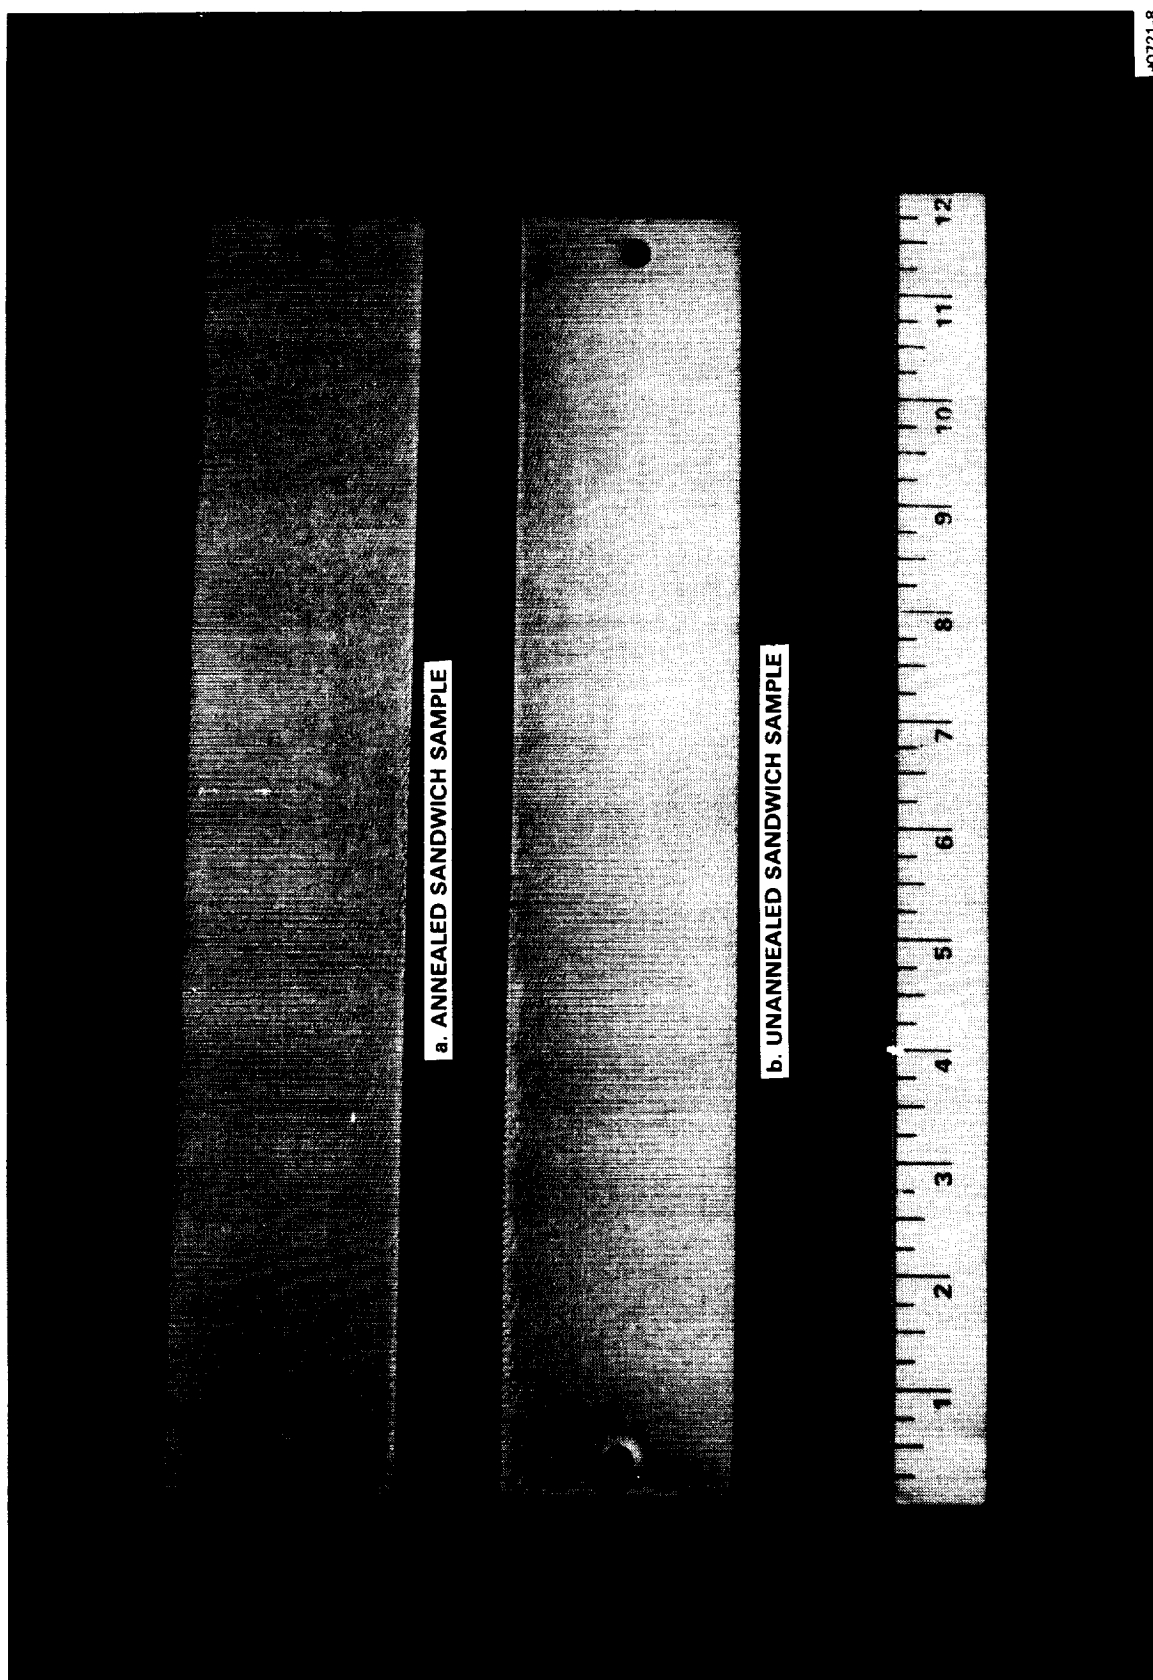
Figure 119. Samples Brazed in Modified Cycle
